Technical Report CHL-97-30  
October 1997

# **Navigation Conditions at Point Marion Lock and Dam, Monongahela River**

## **Hydraulic Model Investigation**

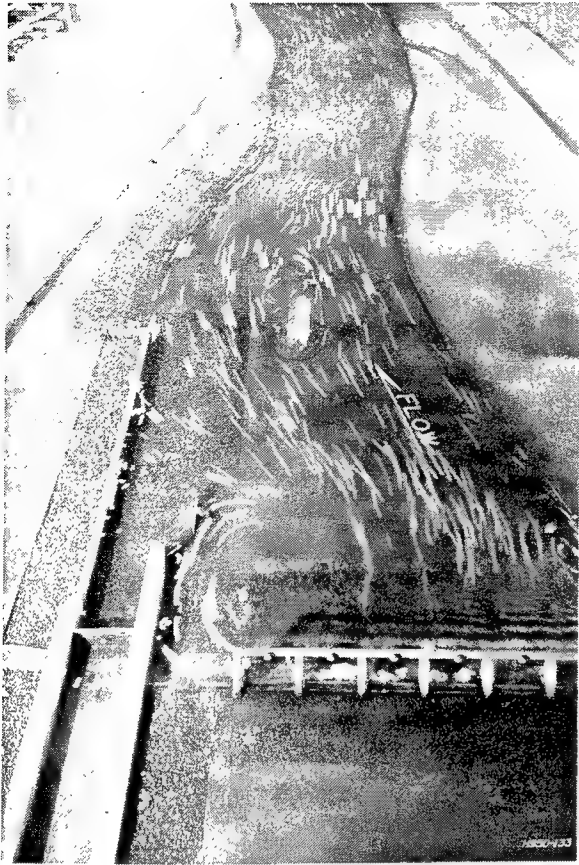
Photo 54. Plan E, drawdown conditions, looking downstream, discharge 55,000 cfs, showing path of upbound tow approaching lock

**Drawdown experiments.** Experiments were conducted with the model reproducing drawdown conditions as defined for Plan B-Modified. The experiments were conducted with the 22,500- and 55,000-cfs riverflows to determine any changes in navigation conditions or current patterns caused by the lower stages of a drawdown condition. During the drawdown experiments, dye and confetti were used to define the current patterns downstream of the dam. Observations of these current patterns were then compared with photographs of Plan E normal pool current patterns. This comparison indicated a slight change in the current alignment in the lower lock approach with the 22,500- and 55,000-cfs riverflows. Current direction and velocities measured with the 55,000-cfs riverflow are shown in Plate 21. These data indicate that the current pattern in the lower lock approach was generally the same as with normal tailwater conditions. However, lowering the tailwater increased the velocity of the currents. The maximum velocities of the currents with the 55,000-cfs riverflow varied from about 6.7 fps near the downstream end of the guide wall, to 6.3 fps about 2,000 ft downstream of the dam, and 6.3 fps about 4,000 ft downstream of the dam. However, navigation experiments with the model tow indicated no significant change in navigation conditions for tows leaving or entering the lower lock approach (Photos 53 and 54). Water-surface elevations measured with drawdown conditions are shown in Table 13. These data indicate a significant change in water-surface elevation due to the nature of the experiments. The drop through the dam varied from about 11.6 to 8.5 ft with the 22,500- and 55,000-cfs riverflows, respectively. The slope in water-surface elevation varied from about 0.1 to 0.4 ft per mile downstream of the dam with the 22,500- and 55,000-cfs riverflows, respectively.

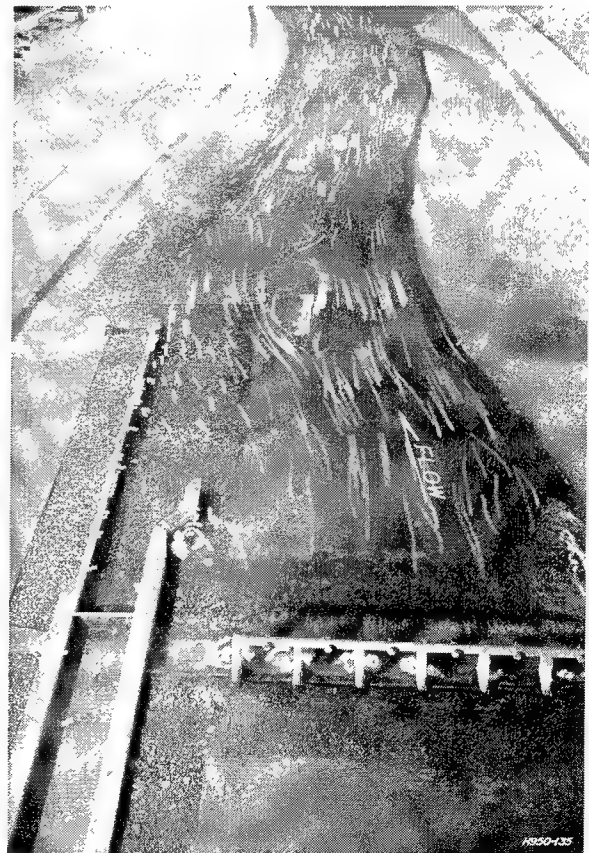
Photo 55. Plan E-Modified, looking downstream, discharge 22,500 cfs, confetti showing surface current patterns in lower lock approach

**Current directions and velocities.** Current direction and velocities obtained with Plan E-Modified are shown in Plates 22-24. Confetti showing the current pattern downstream of the dam and in the vicinity of the lower lock approach is shown in Photos 55 and 56. These data indicate that the current pattern upstream and downstream of the dam was generally the same as with Plan E. The minor change of bank slope and 25-ft difference in length of the upper guard wall had no effect on the current directions or velocities in the upper pool. Any changes in direction or velocities of currents can be attributed to floats being dropped at slightly different locations and taking slightly different paths. Replacing the vane dike that extended downstream from the riverside wall of the lock with a solid angled wall had some influence on the currents in the vicinity of the lower lock approach. A small counterclockwise eddy formed in the lower lock approach between the solid wall and the landside guide wall. The velocity of the currents in the eddy were less than 0.5 fps. With the 22,500-cfs riverflow, a large counterclockwise eddy formed immediately downstream of the weir between the lock and the dam (Photo 55). As the riverflow increased, flow over the weir eliminated the eddy and established downstream flow along the lock wall and the wing wall (Photo 56).

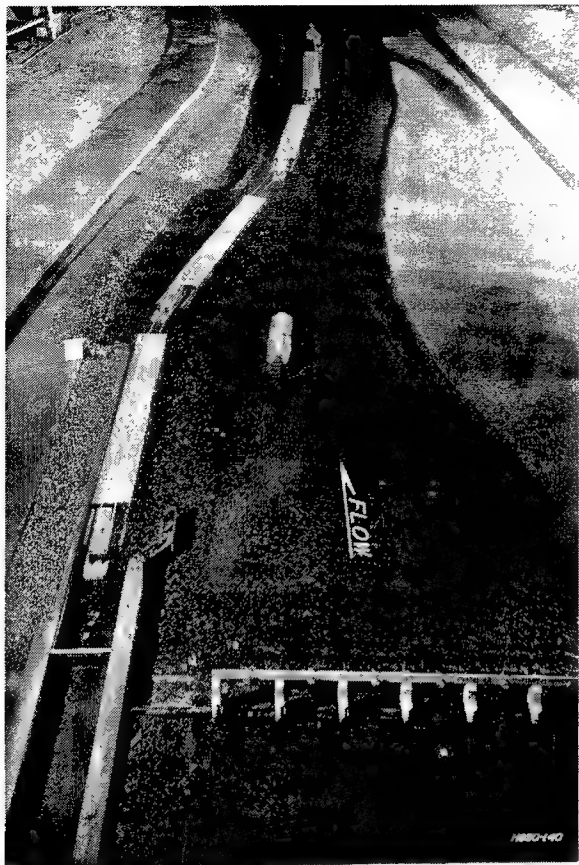
Photo 56. Plan E-Modified, looking downstream, discharge 55,000 cfs, confetti showing surface current patterns in lower lock approach

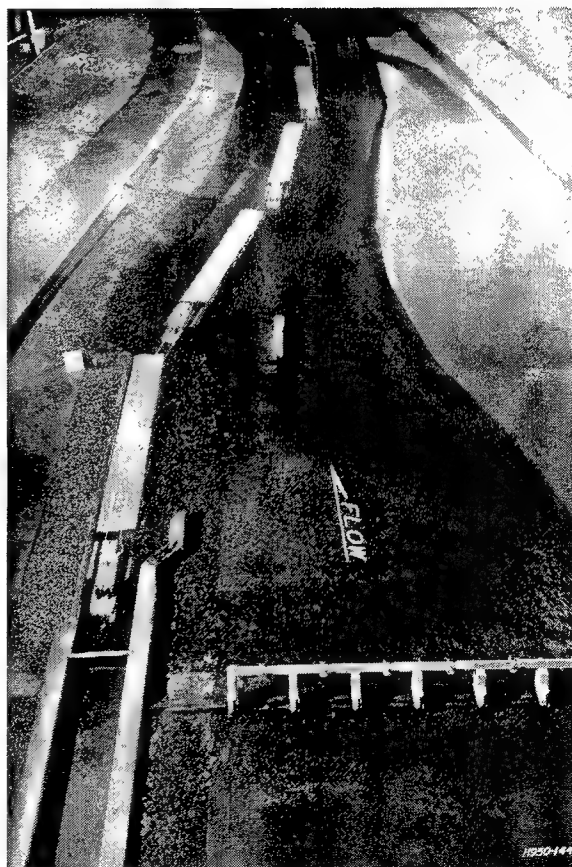
Photo 57. Plan E-Modified, looking downstream, discharge 22,500 cfs, showing path of downbound tow leaving lock

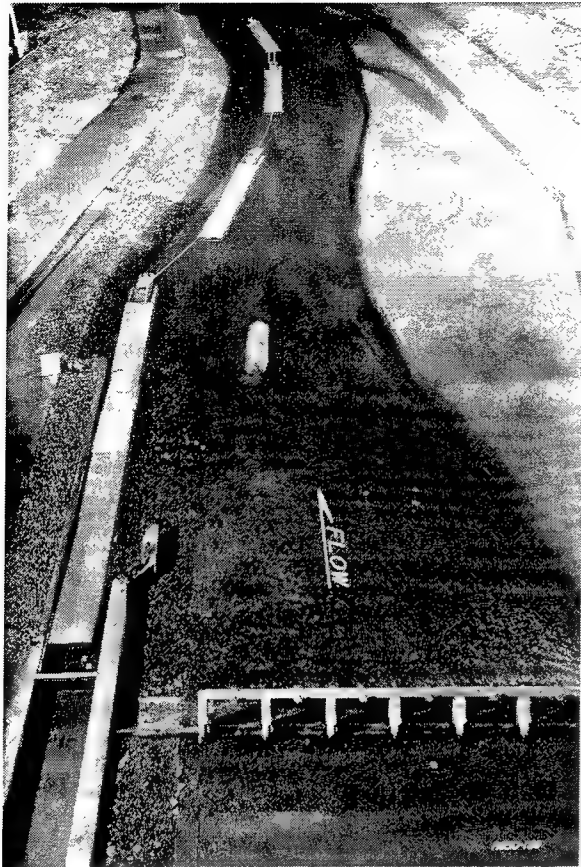
Photo 58. Plan E-Modified, looking downstream, discharge 55,000 cfs, showing path of downbound tow leaving lock

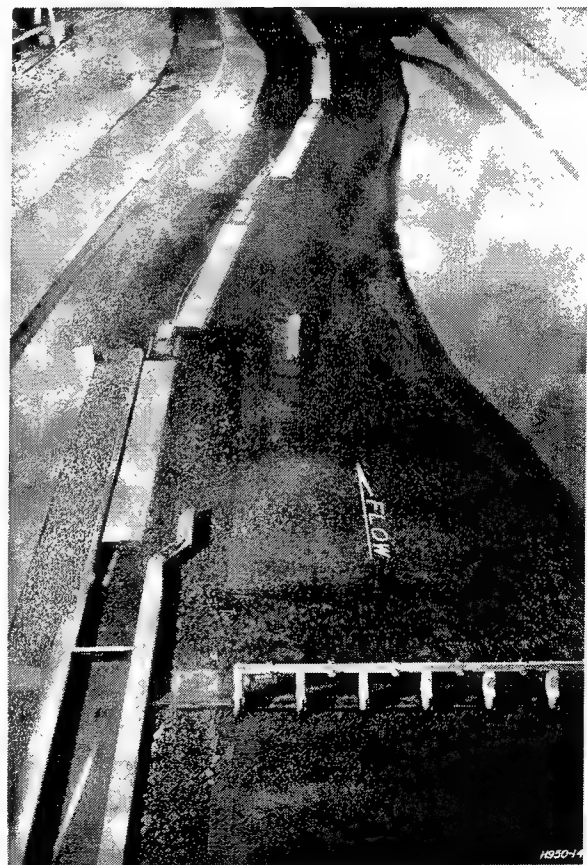
Photo 59. Plan E-Modified, looking downstream, discharge 22,500 cfs, showing path of upbound tow approaching lock

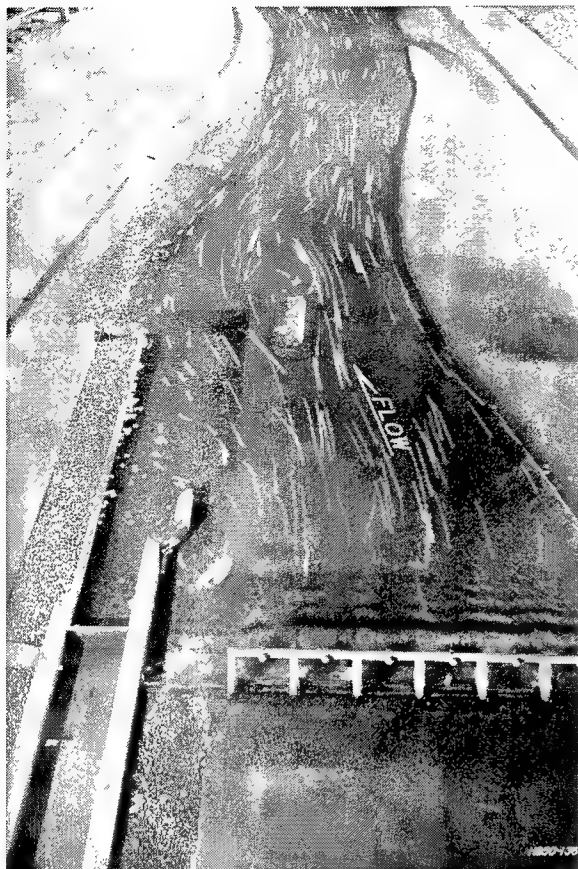
Photo 60. Plan E-Modified, looking downstream, discharge 55,000 cfs, showing path of upbound tow approaching lock

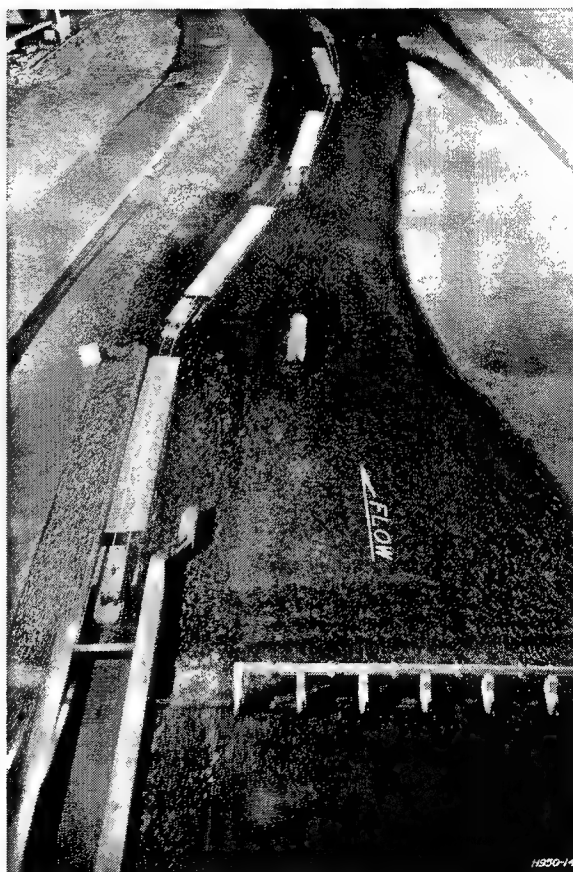
Photo 61. Plan E-Modified, drawdown conditions, looking downstream, discharge 55,000 cfs, confetti showing surface current patterns in lower lock approach

**Drawdown experiments.** Experiments were conducted with the model reproducing drawdown conditions as defined for Plan B-Modified. The experiments were conducted with the 22,500- and 55,000-cfs riverflows to determine any changes in navigation conditions or current patterns caused by the lower stages of a drawdown condition. During the drawdown experiments, dye and confetti were used to define the current patterns downstream of the dam. Observations of these current patterns were then compared with photographs of Plan E-Modified normal tailwater current patterns. Confetti indicating the current pattern downstream of the dam with the 55,000-cfs riverflow is shown in Photo 61. Current direction and velocities measured with the 55,000-cfs riverflow are shown in Plate 25. These data indicate that the current pattern in the lower lock approach was generally the same as with normal tailwater conditions. However, lowering the tailwater increased the velocity of the currents. The maximum velocities of the currents with the 55,000-cfs riverflow varied from about 6.5 fps near the downstream end of the guide wall, to 6.6 fps about 2,000 ft downstream of the dam, and 6.0 fps about 4,000 ft downstream of the dam. Water-surface elevations shown in Table 15 indicate a significant change in water-surface elevation due to the nature of the experiments. The drop

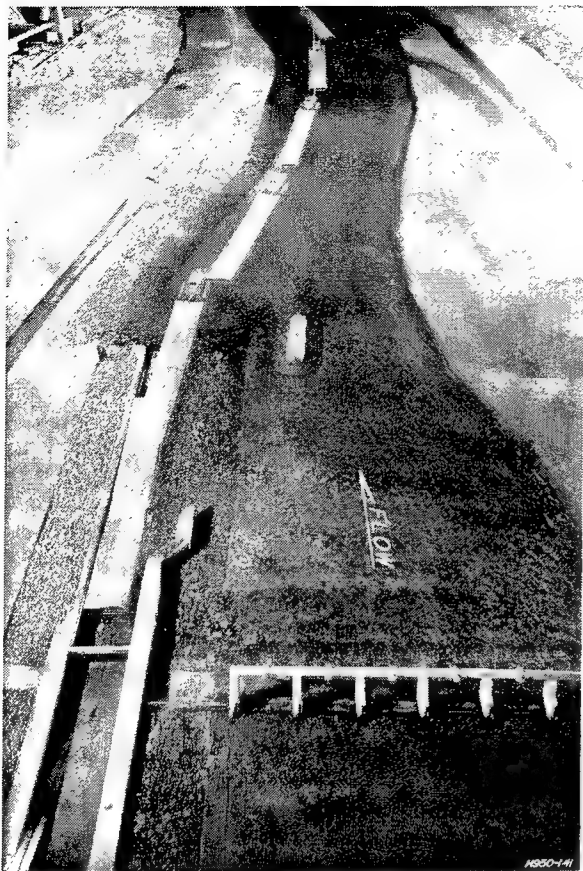
Photo 62. Plan E-Modified, drawdown condition, looking downstream, discharge 55,000 cfs, showing path of downbound tow leaving lock

through the dam varied from about 11.5 to 8.4 ft with the 22,500- and 55,000-cfs riverflows, respectively. The slope in water-surface elevation varied from about 0.2 to 0.5 ft per mile downstream of the dam with the 22,500- and 55,000-cfs riverflows, respectively. Navigation experiments with the model tow indicated no significant change in navigation conditions for tows entering and leaving the lower lock approach (Photos 62 and 63).

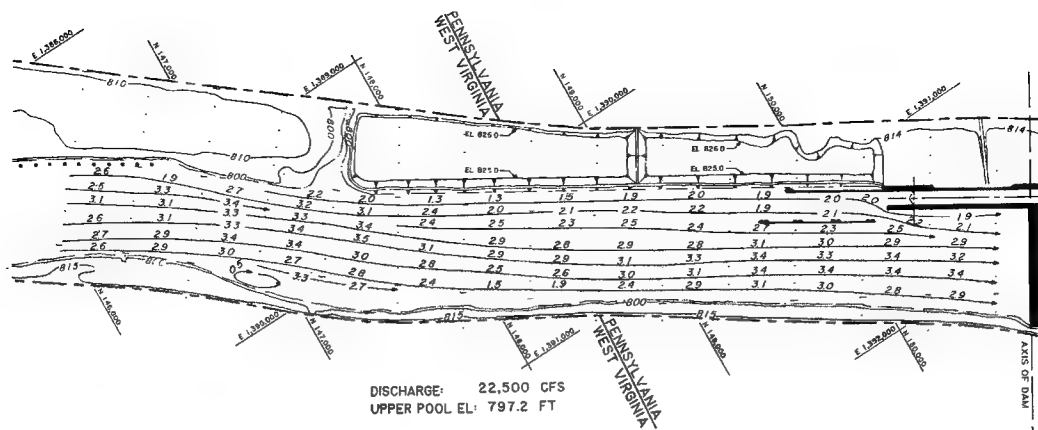
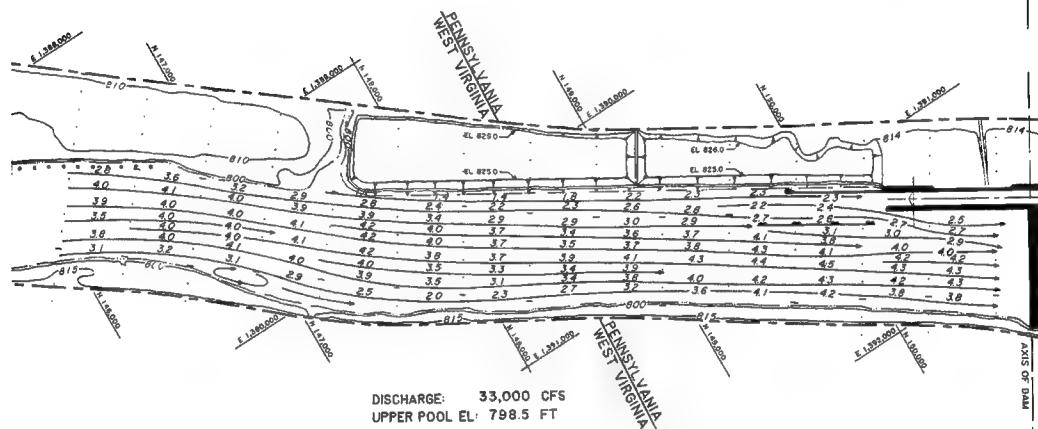
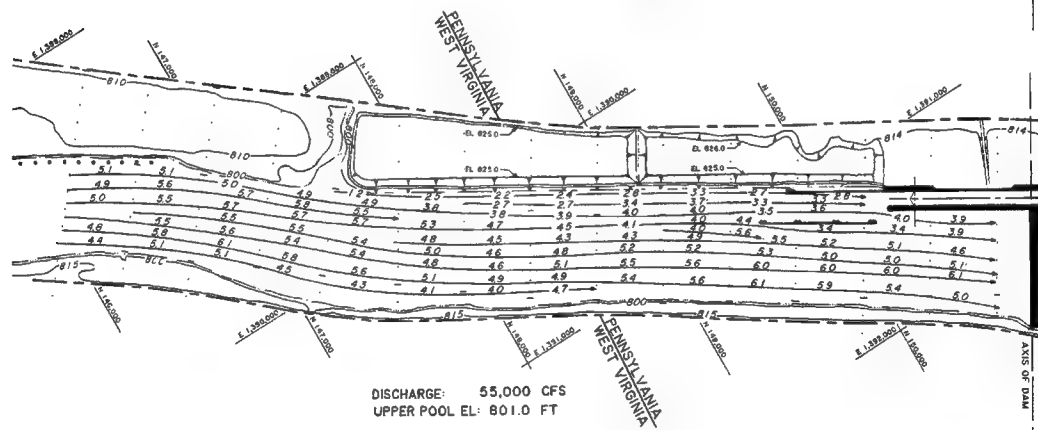
**LEGEND**  
 — 3.2 — VELOCITY IN FEET PER SECOND  
 — 0.5 — VELOCITY LESS THAN 0.5 FEET PER SECOND  
**NOTE**  
 VELOCITIES AND CURRENT DIRECTIONS OBTAINED WITH FLOAT SUBMERGED TO DRAFT OF LOADED BARGE (19 FT)  
 ALL CONTOURS AND ELEVATIONS ARE IN FEET REFERRED TO MVD

MODEL STUDY OF  
 POINT MARION LOCK AND DAM  
 MONONGAHELA RIVER  
 VELOCITIES AND  
 CURRENT DIRECTIONS

PLAN D-MODIFIED
